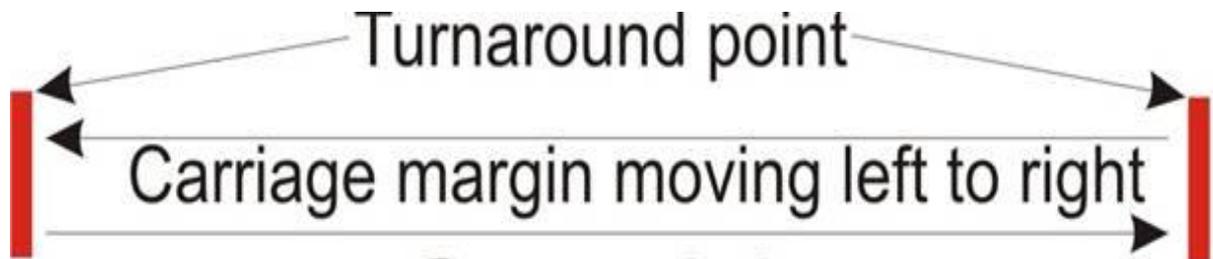
This is when the laser cartridge is “leaking” The gold coated plastic material Mylar you are using is the material this issue is most visible. If you run the application on i.e. wood you will most likely not see this. However, there is unfortunately nothing you can do. A laser exchange is what one need to do if this is essential for the application.

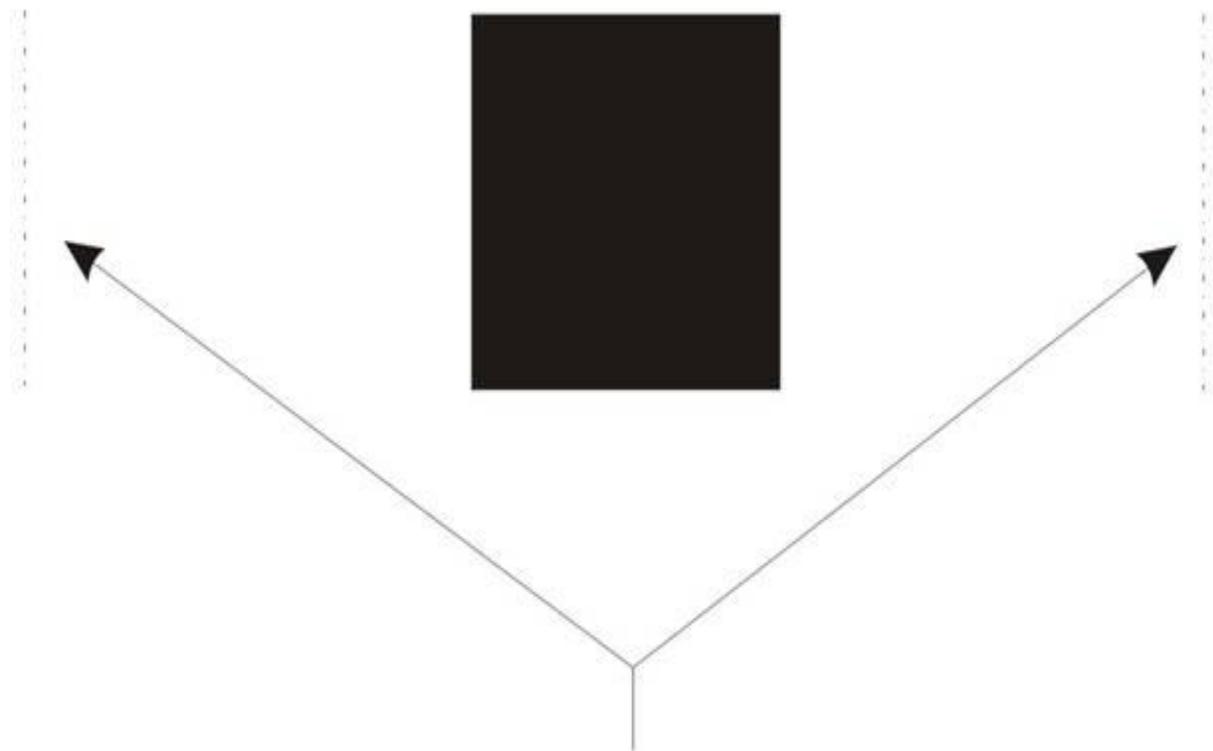
The “leaking” or “shadow” appears here, where the carriage change direction.
