MICROMILL 2000

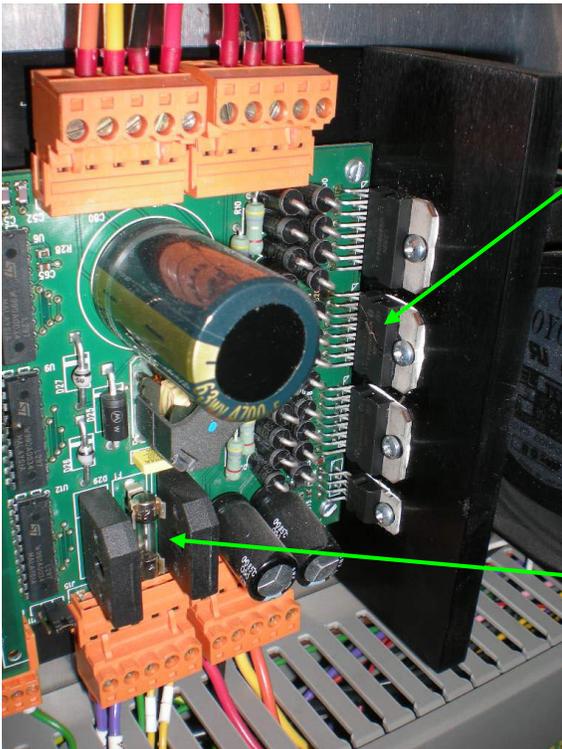
This is where the visible damage to the circuit board is. You just see that the plastic housing of the IC is damaged and this is also where the strongest smell of burning could be detected.
